Water flows downhill, of course, and so does the main trail through the “world’s oldest ecologically-restored prairie.” This guide describes the path that water takes as it flows from an urban watershed of some 144 acres, where rainfall that cannot soak into the ground runs off rooftops, sidewalks and driveways--and collects in gutters that flow downhill toward Curtis Prairie. When the water approaches the Beltline Highway, it goes through a large culvert and into a broken, concrete flume, which carries the water and the contaminants it has gathered into a stormwater retention pond, called Curtis Pond. From there, the water flows onto the prairie through metal and concrete structures, along an eroded creek, and across a sedge meadow, exiting through the eastern culvert (Map A).

Our purpose in inviting visitors to walk this path is to explain how urban runoff sustains wetland vegetation but also brings in contaminants; we also explain how the wetland improves water quality by absorbing, denaturing and removing contaminants. This reciprocal relationship complicates the Arboretum’s need to follow rules about managing both runoff and prairie vegetation.

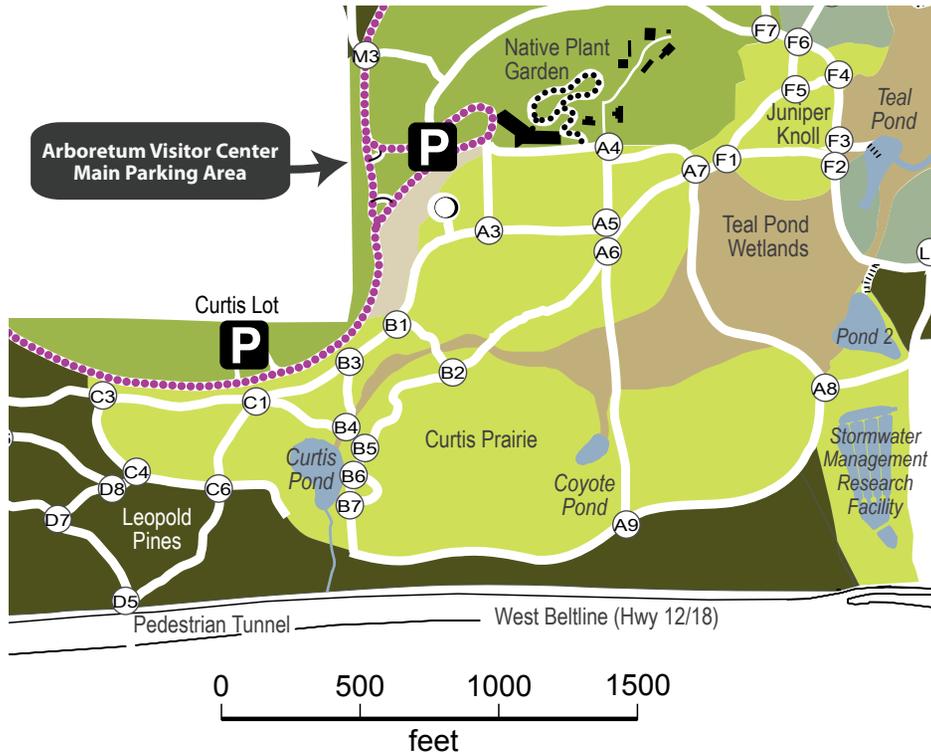
| <ul style="list-style-type: none"> Bike Route Wheelchair Accessible Boardwalk Council Ring Parking | <p>Community types</p> <ul style="list-style-type: none"> Horticulture Coniferous forest Deciduous forest Savanna Prairie Wetlands Open water Buffer zone |

1 Park at the Curtis Prairie lot and bring the beautiful Prairie Plants book, which describes ~230 plants that live in Arboretum prairies. The book is available at the Visitor Center. The map in this leaflet shows locations of posts.
